Interim Report on NBS Thermal Integrity Diagnostic Tests on Eight GSA Federal Office Buildings

September 1983

**INTERIM REPORT ON NBS THERMAL
INTEGRITY DIAGNOSTIC TESTS ON
EIGHT GSA FEDERAL OFFICE BUILDINGS**

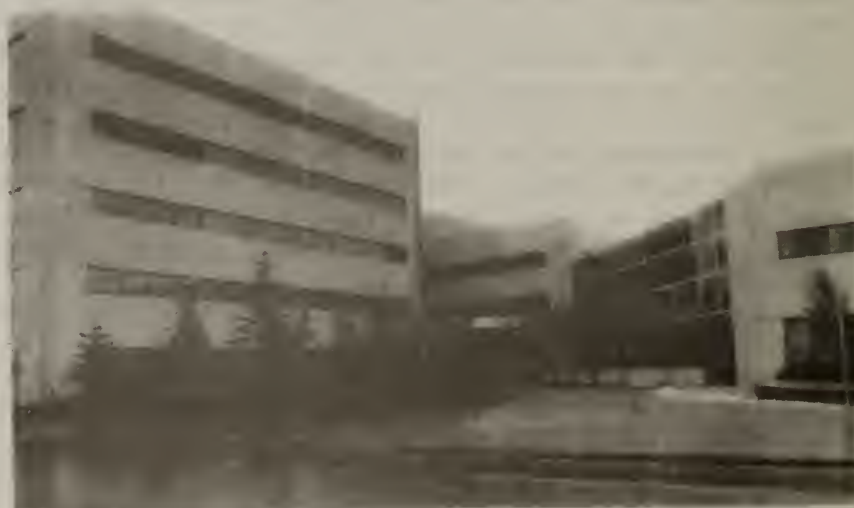
Figure 2. Schematic Diagram and Photograph of Federal Building in Anchorage, AK

ANCHORAGE FEDERAL BUILDING
Schematic of Overhead view

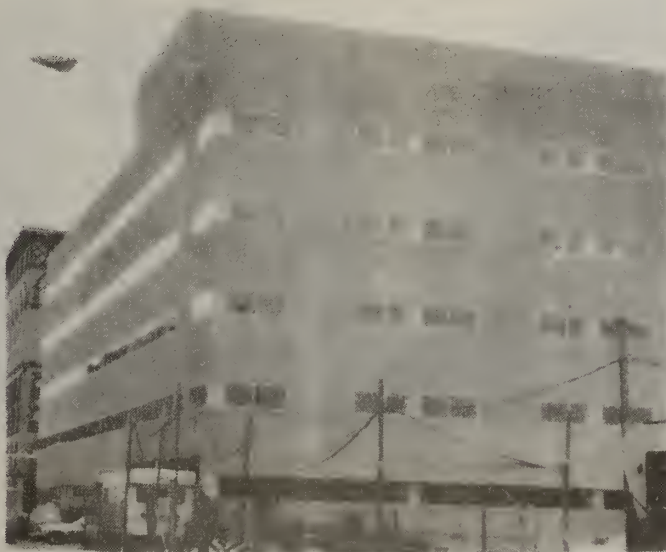
Figure 3. Schematic Diagram and Photograph of Federal Building in Springfield, MA

SPRINGFIELD FEDERAL BUILDING Schematic of South Elevation

SPRINGFIELD FEDERAL BUILDING Schematic of First Floor

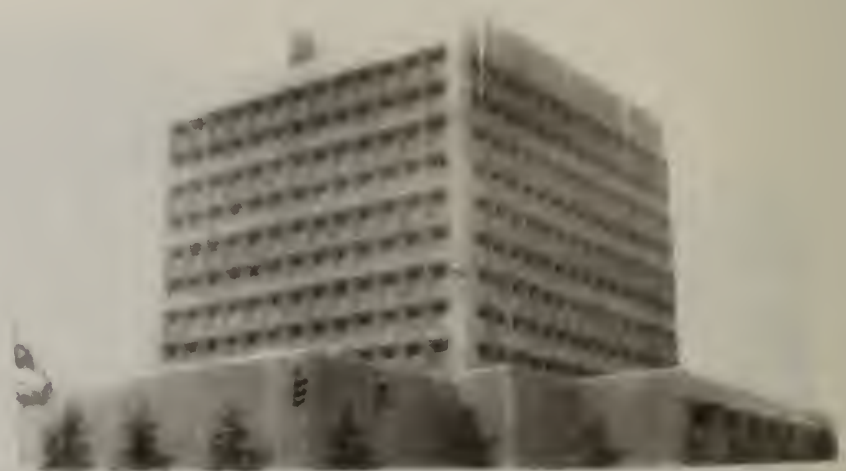
Figure 4. Schematic Diagram and Photograph of Federal Building in Columbia, SC

COLUMBIA FEDERAL BUILDING **Schematic of East Elevation**

COLUMBIA FEDERAL BUILDING **Schematic of Overhead View**

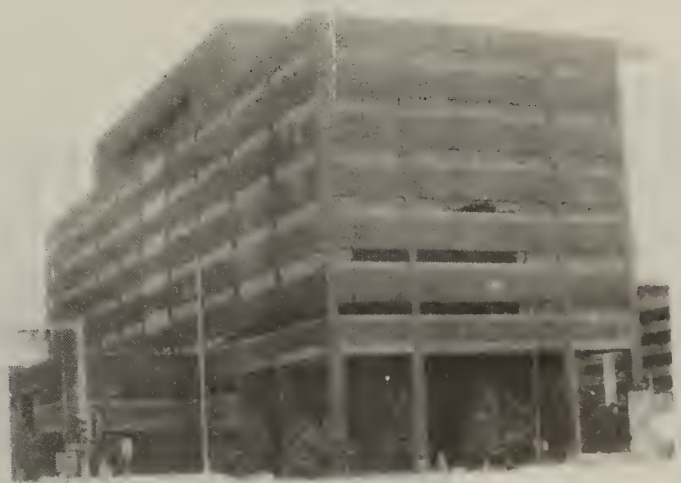
Figure 5. Schematic Diagram and Photograph of Federal Building in Norfolk, VA

NORFOLK FEDERAL BUILDING Schematic of West Elevation

NORFOLK FEDERAL BUILDING Schematic of North Elevation

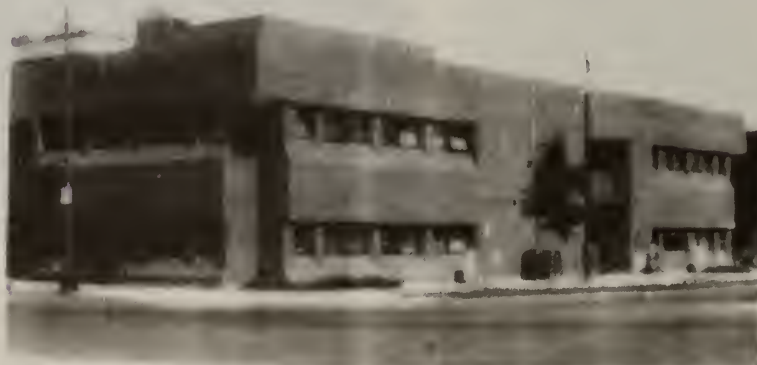
Figure 6. Schematic Diagram and Photograph of Federal Building in Pittsfield, MA

PITTSFIELD FEDERAL BUILDING
Schematic of West Elevation

PITTSFIELD FEDERAL BUILDING
Schematic of Overhead View

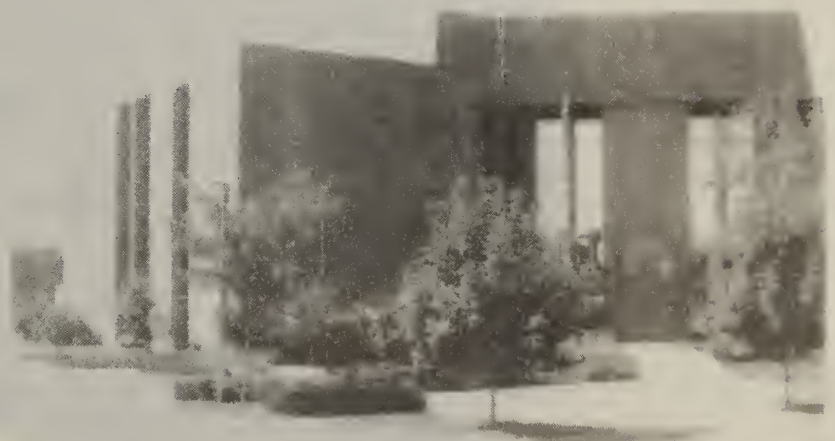
Figure 7. Schematic Diagram and Photograph of Federal Building in Huron, SD

HURON FEDERAL BUILDING **Schematic of East-West Building Section**

"North" Wing	Mechanical Penthouse		"East" Wing
	North return ▲	East return ▲	
4th Floor north ▲			▲ 4th Floor east
3rd Floor north ▲			▲ 3rd Floor east
2nd Floor north ▲			▲ 2nd Floor east
1st Floor north ▲			▲ 1st Floor east

HURON FEDERAL BUILDING **Schematic of Overhead View**

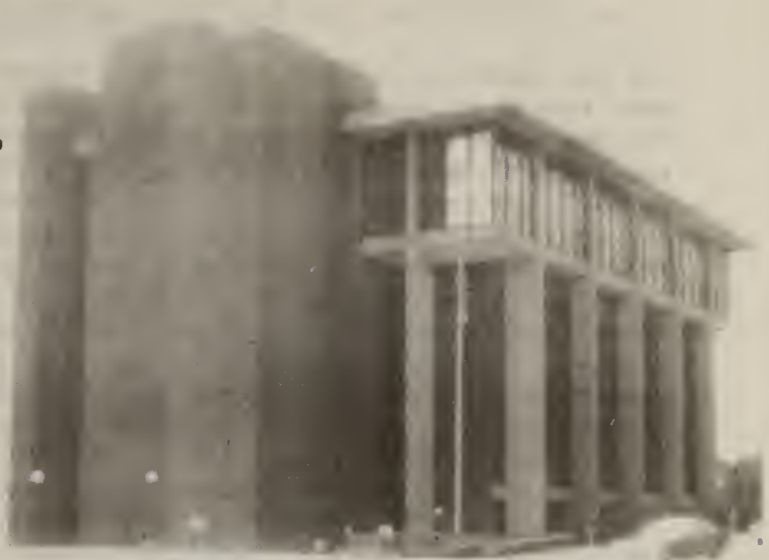
Figure 9. Schematic Diagram and Photograph of Federal Building in Fayetteville, AR

FAYETTEVILLE FEDERAL BUILDING **Schematic of North Elevation**

Elevator room		Sample locations	Courtroom fee
Mech room	▲ 5th Floor	Courtroom ▲	
Mech room	▲ 4th Floor		
Mech room	▲ 3rd Floor		
Mech room	▲ 2nd Floor		
Mech room	▲ 1st Floor

Schematic of First Floor

Schematic of Fifth Floor

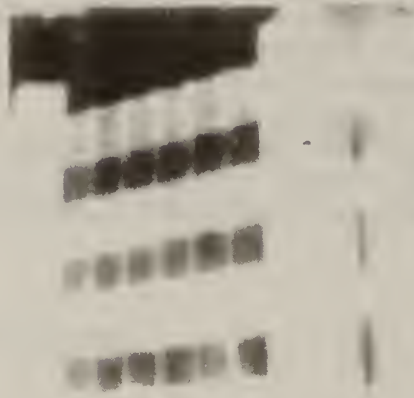
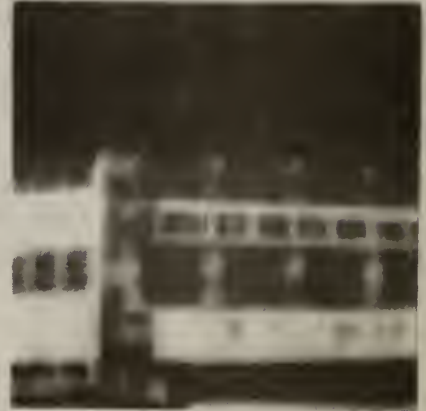
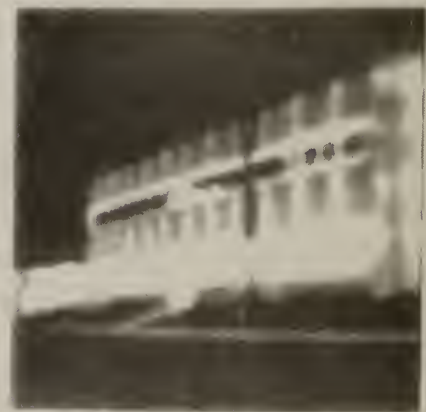
Figure 13. Thermal Defects Observed in the Anchorage Building

The Federal Building in Anchorage, AK, is rather uniform in its thermal anomalies, for the defects in the modules are consistent and regular and the modules are nearly identical to one another, discounting the differences in the number of floors. The major defects are the thermal bridging at the panel supports and the leakage that occurs at the seams of the interlocking panels, especially at the corners and along the edges of the adjoining mirror walls, as illustrated in the thermograms from figures 13-1, 13-2, and 13-3. The mirror walls in figure 13-1 appear with bands of light and dark as the light bands have one-way mirrors for the floors inside and the dark bands have walls behind them. The high rating, 18%, of wall area exposed to thermal defects is primarily due to this corner leakage and thermal bridging at the structural supports of the panels. Examples are the SW corner of the A module in figure 13-2 and the vertical seams in figures 13-3 and 13-4. (The bright spot in the center of figure 13-3 is the heat from a streetlight.) There also is extensive heat loss from the first floor windows that are on every module as illustrated by the west face of the A module in figure 13-4.

13-1
Mirror wall section

13-2
SW corner of
A module

13-3
SE corner with E wall,
upper floor F module

13-4
West face of the
A module

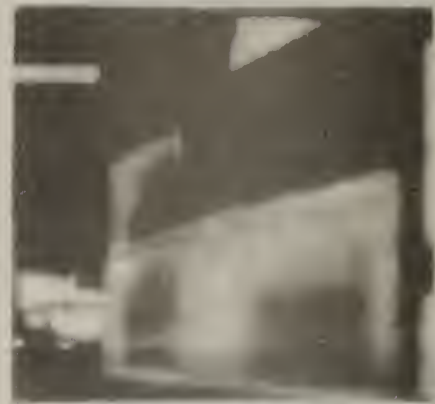
Figure 14. Thermal Defects Observed in the Ann Arbor Building

The Federal Building in Ann Arbor has many types of thermal anomalies, but the predominant defect is the lack of insulation in large rectangular sections in the east and west walls. Note the large heat loss areas in figures 14-2, 14-4, and 14-5. There are similar voids in the insulation in the wall outcroppings that face east in the top center of the building as seen in figure 14-6. Leakage in the seams is also a distinct problem in the building, as the heat loss is evident in the thermograms of the adjoining panels in figures 14-1 and 14-2. The floor-to-floor joints are sources of heat loss as well and are found in nearly all exterior wall areas. The strong flaring in the close-up of the east wall at the south end, as shown in figure 14-3, is indicative of serious thermal defects due to air leakage in the top seams. Note the cross-brace in the thermogram of the Post Office in figure 14-5 and some incompletely or unevenly insulated walls in figures 14-2 and 14-6 which the irregular voids indicate.

14-1
Middle two floors
of SW corner

14-2
Top floors of the
W wall at the S end

14-3
E wall at the
S end

14-4
E wall at the
S end

14-5
E wall at the N
end, first floor
Post Office

14-6
N face above and to
the left of the front
entrance

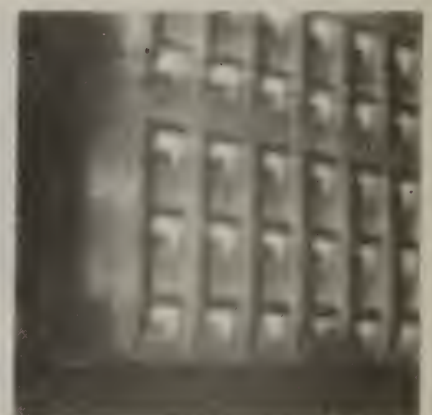
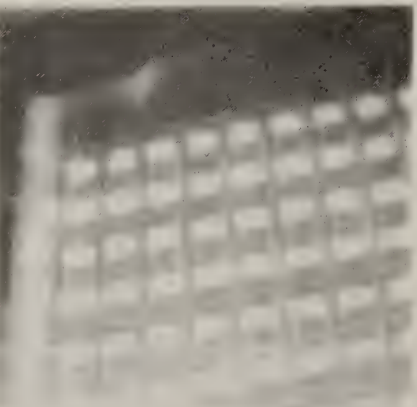
Figure 15. Thermal Defects Observed in the Columbia Building

The thermal anomalies observed in the Federal Building in Columbia, SC, consist primarily of leakage through defects in the window panels and voids in the insulation at the panel seams. The thermograms shown in figures 15-1 and 15-2 made by interior inspections illustrate some of the thermal defects, such as poor insulation, missing insulation, and compression of insulation around the window areas of this building. Figures 15-3 and 15-4 indicate the compression and voids in the insulation in the north wall of the fourth floor by interior and exterior thermograms, respectively. Similar defects over the entire building are the main contributors to the high percentage, 17%, of wall area subjected to thermal anomalies. Note the seam leakage in the panels that make up the solid edges in figure 15-4. The heat loss depicted in figure 15-5 which rises up the west edge of the south wall and across the top edge of the building is due to the perimeter zone HVAC system ducts. The thermal integrity of the courthouse adjacent to the tower is also imperfect. Figure 15-6 shows the leakage that occurs at the NW corner indent of the courthouse, which is typical of the leakage at those seams.

15-1
N wall on the fourth
floor of the tower
(interior)

15-2
N wall on the fourth
floor of the tower
(interior)

15-3
SE corner of the
fourth floor
of the tower (int)

15-4
Lower west face of the
tower at the N end

15-5
S face with W end

15-6
NW corner indent of the
courthouse

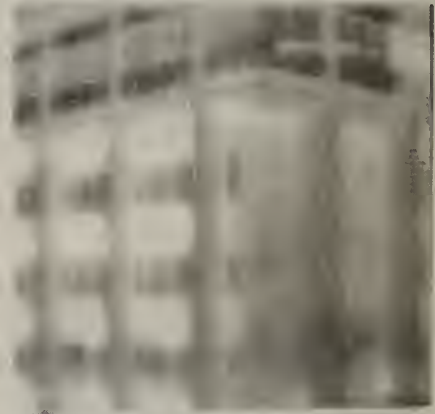
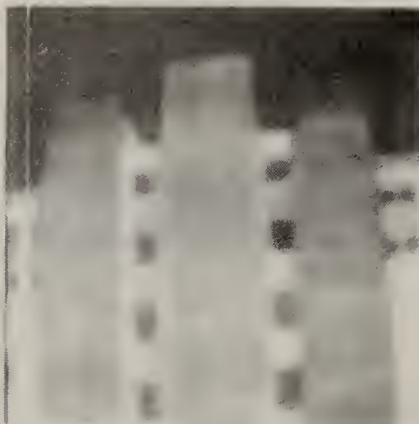
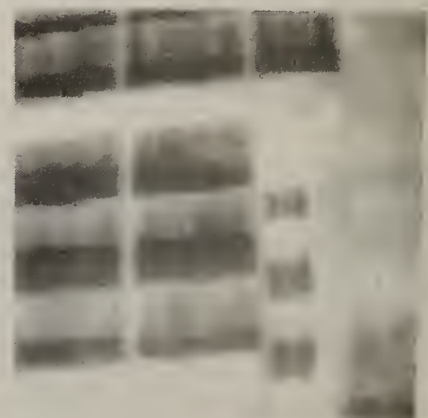
Figure 16. Thermal Defects Observed in the Fayetteville Building

Of all the Federal Buildings inspected, the wall areas of the Fayetteville Building are observed to be relatively uniformly insulated, however this is actually due to a lack of insulation in the exterior wall envelope. This indicates the limitation placed on infrared methods when applied to uninsulated walls. The leakage of the floor-to-floor seams are the prominent defects. Examples are the seams of the elevator towers as shown in figures 16-1 and 16-3. This type of thermal defect is also evident in the east and west walls below the overhangs where the roof of the overhanging section appears to be a source of heat loss as seen by the flaring against the tower in figure 16-1. Note that the heat loss through the floor of the overhangs could be due to the corner seams, for the defect is well-defined along the edges of the overhanging floor. There are relatively few insulation voids which helps account for the low 6% thermal defects of the total wall area.

16-1
NE corner with one
east face tower

16-2
NW corner with west
wall under overhang

16-3
E end with three
elevator towers

16-4
NW corner above N entrance
with view up to overhang

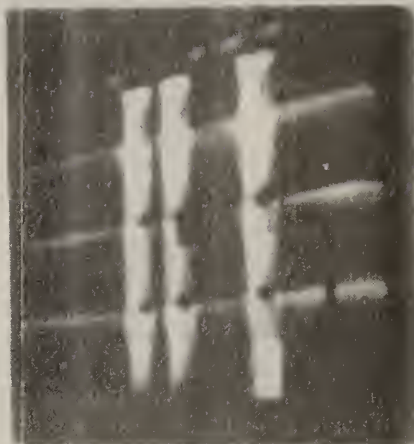
Figure 17. Thermal Defects Observed in the Huron Building

The Federal Building in Huron, SD, is relatively sound with respect to thermal integrity. The 9% thermal defects in wall area is primarily due to leakage through seams between floors and thermal bridges at intersections of walls, floors, and beams, as seen in figure 17-3. There is also an amount of flaring around and above the windows as shown in figures 17-1 and 17-3. Note how the seams appear to be more defective as they approach the windows, especially as seen in figure 17-3. The brightness in the leftmost side of figure 17-2 is due to the windows near the front entrance in the background. Figure 17-4 is an interior thermogram of the fourth floor indicating a beam which conducts cold air in on the right hand side. Figure 17-4 also depicts some shrinkage in the insulation in the third and fifth sections of the wall, as well as air leakage at the top and the bottom of the wall where it intersects the floor and ceiling.

17-1
E wall with NE
entrance off to right

17-2
N face with NE
entrance on left

17-3
Close-up of middle
section on E wall as
shown in 5-2

17-4
Fourth floor interior
N wall of the E wing

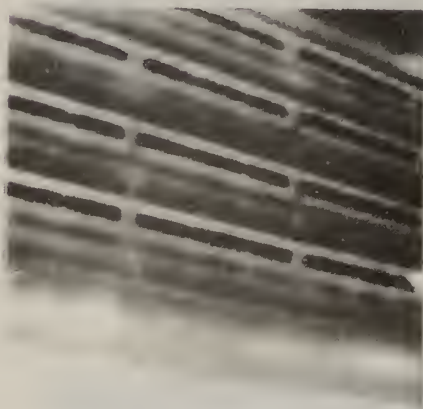
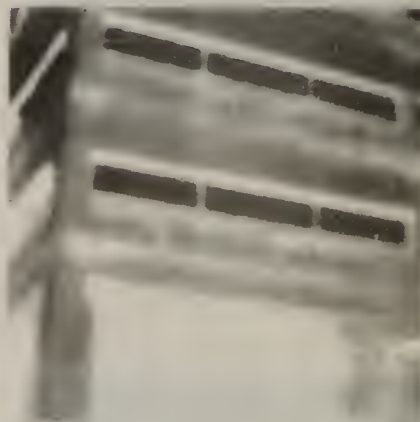
Figure 18. Thermal Defects Observed in the Norfolk Building

The thermal anomalies observed in the Federal Building in Norfolk, VA, consisted of two basic kinds, the leakage that occurred at the wall-to-floor seams and the leakage at the exterior panel seams. In figure 18-1, there is a great deal of heat loss shown at the panel seams in the middle of the east wall. The wall-to-post-to-floor seams are also sources of heat loss as illustrated in figures 18-2 through 18-5. Figure 18-2 shows an interior thermogram of the west wall at the south end. (The middle window does not have the blind pulled down and is not reflecting.) Note the vertical darker area in the center of the picture, which is a beam conducting cold inwards. Figures 18-3, 18-4, and 18-5 show leakage between the windows and from the panel seams in the solid wall sections below, which correspond to the horizontal, long, bright white areas across the entire length of the building. Other thermal defects observed include the floors of the third floor and second floor overhangs, as evidence of voids in insulation and leakage at the seams is identified in figures 18-5 and 18-6.

18-1
Lower wall section
of E wall

18-2
W wall at S end on
the third floor

18-3
W face at the N
end

18-4
E wall at the
SE corner

18-5
Third floor overhang
of the N wall at the
W end

18-6
NE overhang of second
floor over garage

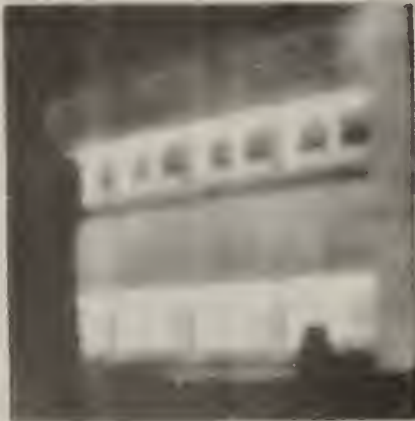
Figure 19. Thermal Defects Observed in the Pittsfield Building

The thermal integrity of the Federal Building in Pittsfield, MA, can be characterized by a large number of markedly undefined voids in the insulation. Many sections have insulation that is distributed unevenly, and there are areas where a whole section of wall is lacking insulation as shown in figure 19-2, where the top third of the wall next to the front entrance is distinctly warmer. The large percentage, 18%, of defective wall observed in the Pittsfield Building is due to these large rectangular voids, but the problems with all types of seams must also be taken into consideration. In figure 19-1 for example, note the leakage from the seam below the second floor windows and the wall-to-wall seam in the upper right-hand corner. The posts running through the walls also cause heat loss as shown in figures 19-4 and 19-6. These two thermograms are characteristic of those for every wall-to-post seam in the building. At each corner there is an indentation in which there is leakage as illustrated by the thermograms in figures 19-3 and 19-4, where the exterior and the interior of the NW corner on the first floor are shown. The dark line in figure 19-4 indicating the penetration of cold corresponds to the bright white regions in figure 19-3 which indicate heat loss to the outside. Other defects observed in this building include the possibility of a damaged pipe inside the north wall as shown in figure 19-5, where a flaring warm area near the top is detected.

19-1
S end of E wall
(exterior)

19-2
The front entrance
on E wall (exterior)

19-3
NW corner with N
wall section and
indent (exterior)

19-4
NW corner with W
window and
indent (interior)

19-5
Center of N wall
(exterior)

19-6
Wall-post seams on E
wall first floor
(interior)

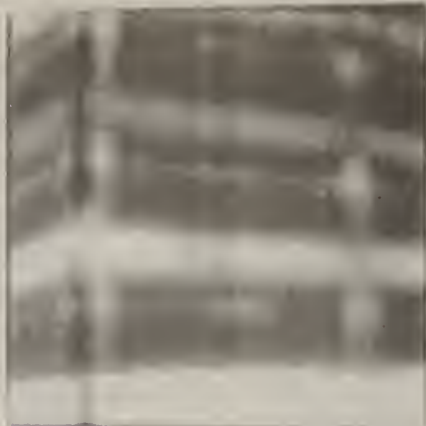
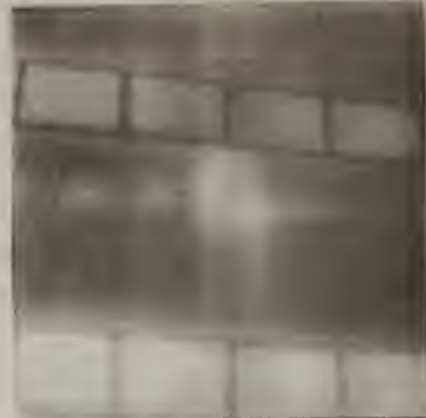
Figure 20. Thermal Defects Observed in the Springfield Building

The Springfield Federal Building has a relatively low, 7%, rating of wall area subject to thermal anomalies. The main defect is the post-to-wall joints as seen in figures 20-1 through 20-6. Note the consistent pattern of the defect in figures 20-1 and 20-3. An exterior close-up of the post-to-wall seam is shown in figure 20-2 at the SW corner with an interior view in figure 20-4. The dimensions of the columns are defined in figures 20-1 and 20-2 by the heat loss that occurs at the edges as the column rises up the side of the building. The interior view shows the cold penetrating to the interior at the sides of the pillar at a single floor. The heat loss from the joints is also consistently evident at the corners, where there are small insulation voids above the windows as well which can be observed in figure 20-3 and 20-5. There is also a great deal of heat loss from the glass windows on the first floor and from the atrium which rises up the center of the east face of the building, as shown in figures 20-5 and 20-6.

20-1
SE corner of
the N wing

20-2
Close-up of the floor-wall-
post seam on the E face of
the N wing

20-3
SW corner showing seams
at the second and third
floors

20-4
Interior thermogram of
the wall-post seam

20-5
S wall first floor
glass wall with metal
panel, W end

20-6
Atrium rising up
center of E face
